Case Study Topic: *What changes could be made to minimize risk of high thermal stresses when a cold front is expected to pass by soon after concrete placement?*

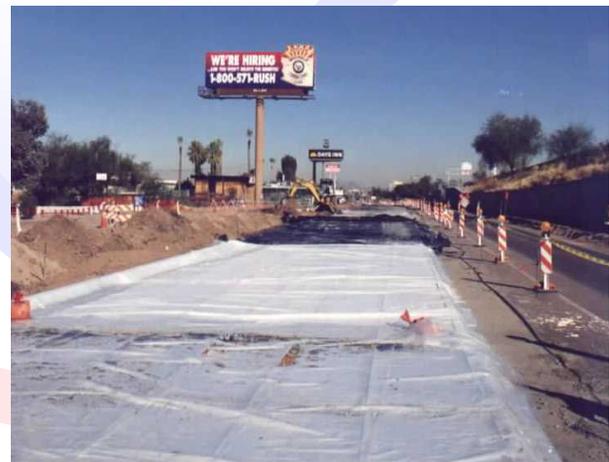
Figure 1. Pavement protected with polyethylene sheets.

The results for the evaluation of different curing methods are presented in Table 2 in terms of the critical strength to stress ratio observed throughout the 72 hrs of analysis. Table 2 shows that polyethylene sheeting and/or cotton mats would provide the best alternative to avoid risks of cracking in the pavement for the sections placed in the morning. Either of those alternatives should be
